CHAPTER THREE: COMMERCIAL REHABILITATION GUIDELINES

3.1. Storefronts (Entrances, Windows, and Awnings)

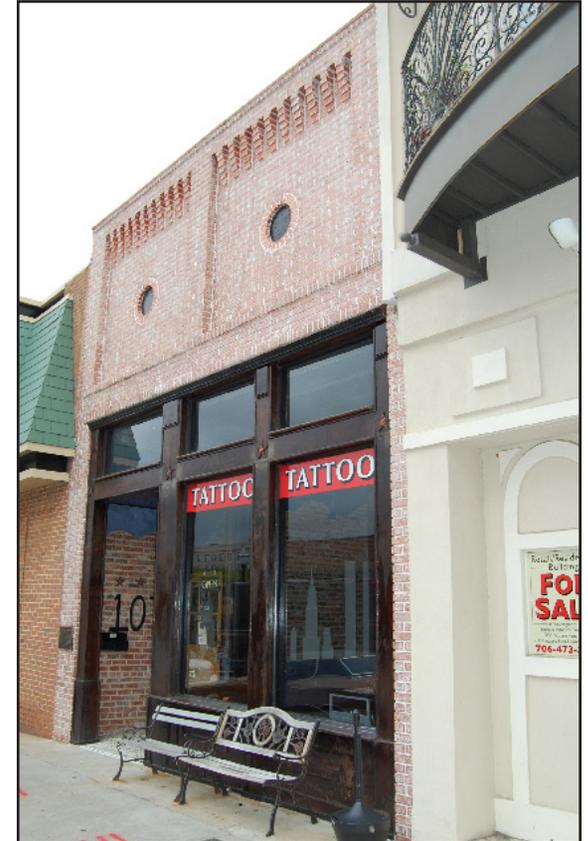
Figure 3.03: This storefront in Gainesville, GA was recently rebuilt after the nonhistoric masonry infill of the storefront was removed in 2007. There was no documentation of the previous storefront so this contemporary version was built.

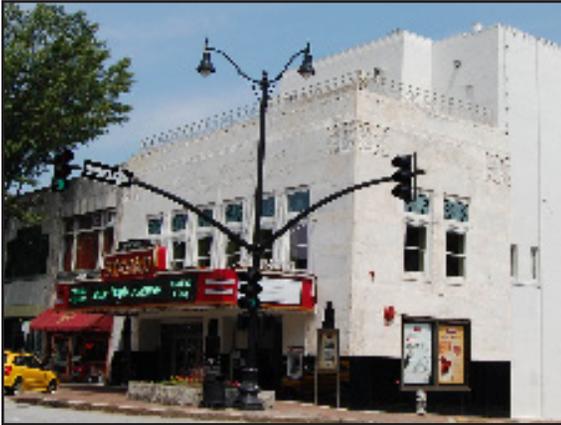
Figure 3.02: The marquee of The Strand Theater is a character-defining feature of this local landmark and should be retained during any rehabilitation/restoration work on the theater.

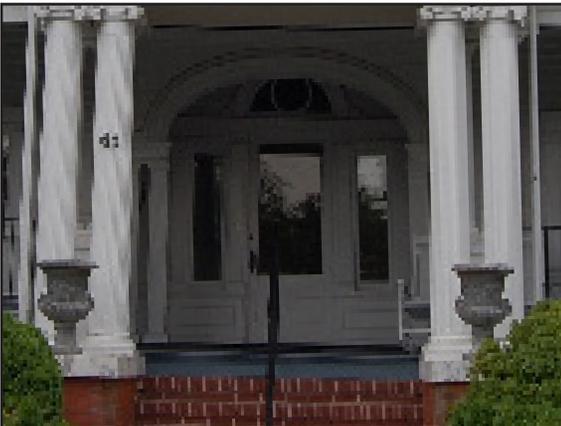
Figure 3.03: This building has original windows, window and door openings – all of which should be retained and maintained during the building’s lifetime.

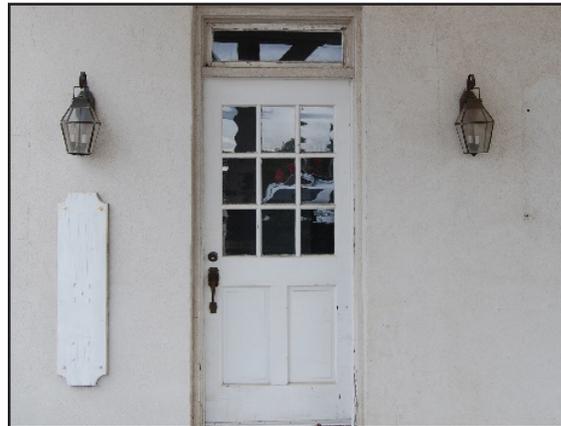
Figure 3.04: The residential style door and lanterns are inappropriate for this historic commercial building in Gainesville, GA.

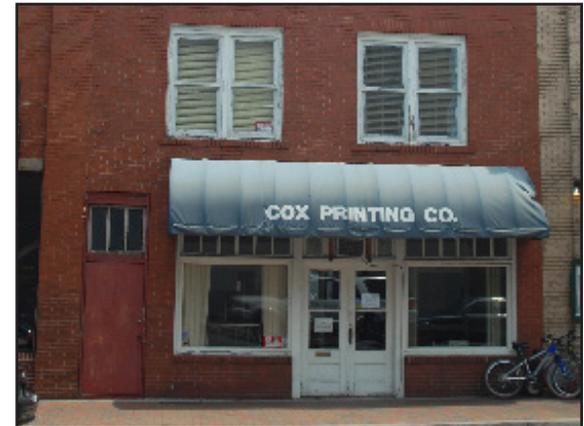
Figure 3.05: The original entrance and display windows with integrated transoms are still intact on the Cox Printing Building in Marietta. These are character-defining features and should be retained and maintained by the property owner.

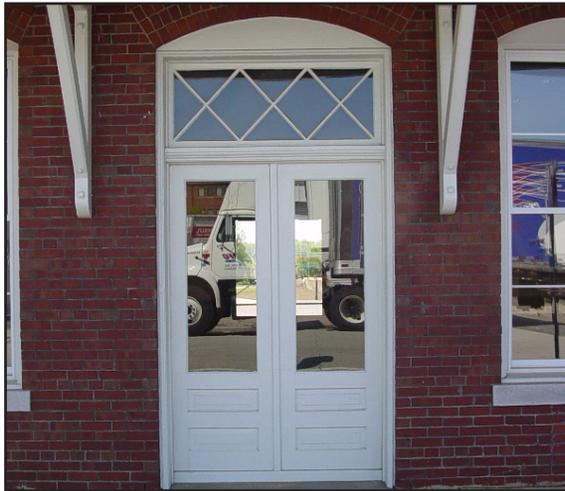
Figure 3.06: This modern door at the Railroad Depot off of the Square in Gainesville, GA is appropriate to the commercial character of the Depot.

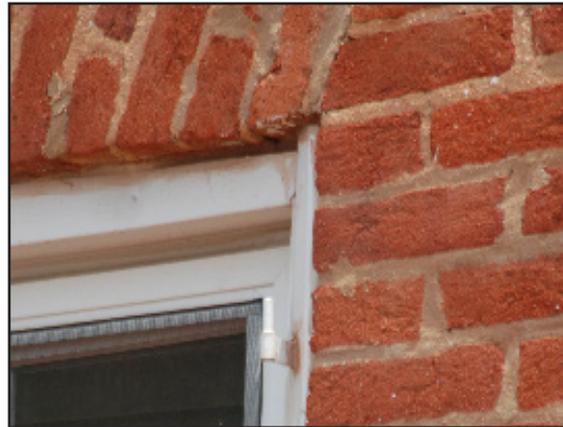
Figure 3.07: This historic pinion for a shutter was appropriately retained when the Kennesaw House was rehabilitated for a

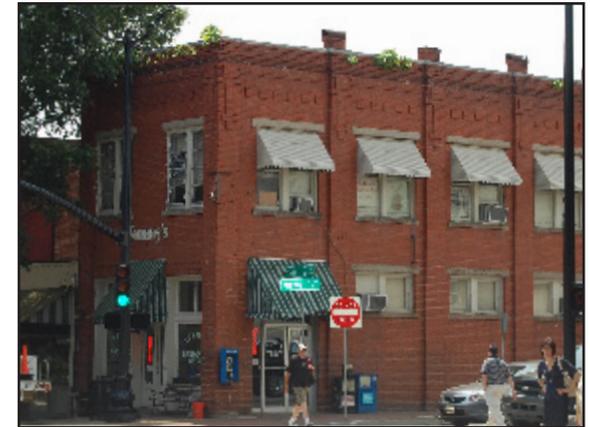
Figure 3.08: This building at the corner of Roswell Street and Atlanta Street has appropriately retained the character-defining corbelled brickwork and chimneys along the parapet wall.

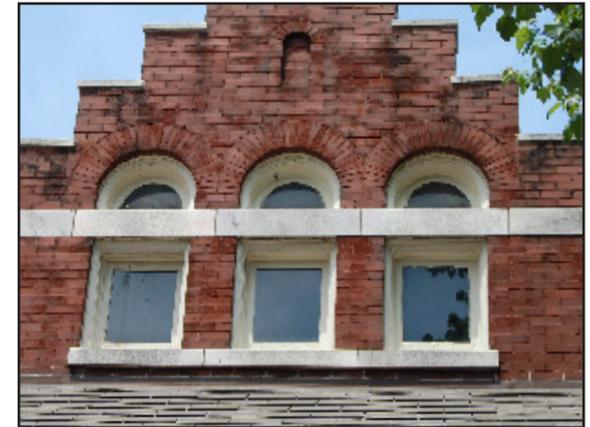
Figure 3.09: This arched, triple-paired windows on the Marietta Depot are character-defining features of the depot

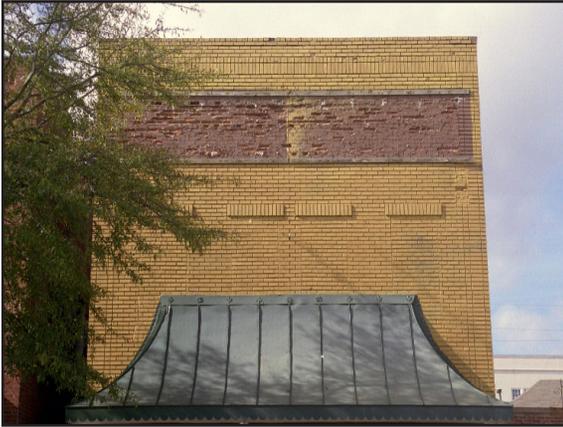
Figure 3.10: This building in south Georgia has had its cornice removed and its upper story windows infilled. The removal of intact historic architectural features and the infill of windows on a primary elevation is inappropriate.

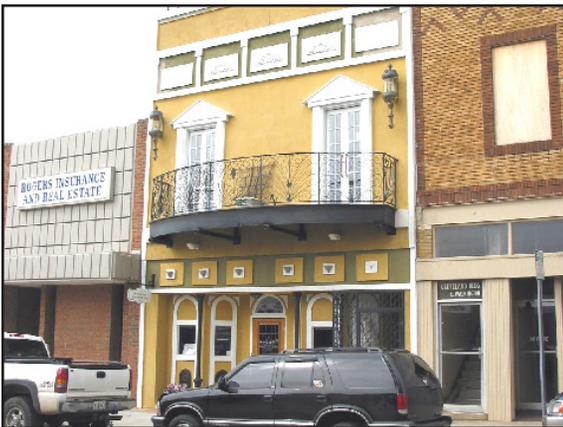
3.11: This building in Gainesville, GA has had faux and inappropriately scaled decoration added to it that has removed

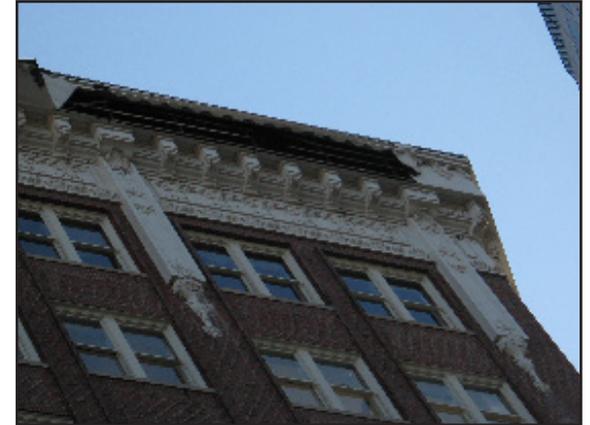
Figure 3.14: This cornice in Atlanta, GA was damaged by a tornado. During rehabilitation of this building the damaged cornice panels are being repaired by a metal works and will be replaced.

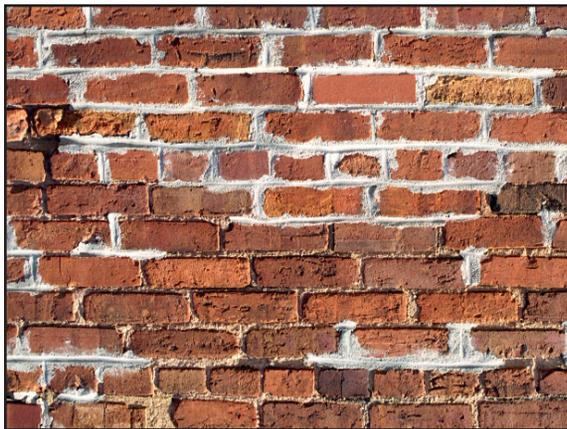
Figure 3.12: This brick has been inappropriately repointed (replacement of mortar joints) with a mortar stronger than that that was used originally so that the bricks are spalling.

3.3.06 When repair or replacement of mortar is needed, the new mortar should duplicate the old in current strength, composition, color, texture, and mortar joint width. A high content of Portland cement is not appropriate when repointing historic masonry joints as the extant mortar and brick may not be as strong as the Portland cement causing extensive damage.

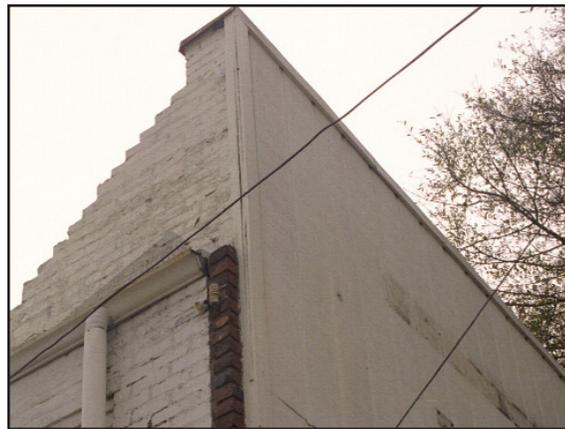
Figure 3.13: The application of painted plywood panels of this historic brick exterior in South Georgia is inappropriate.

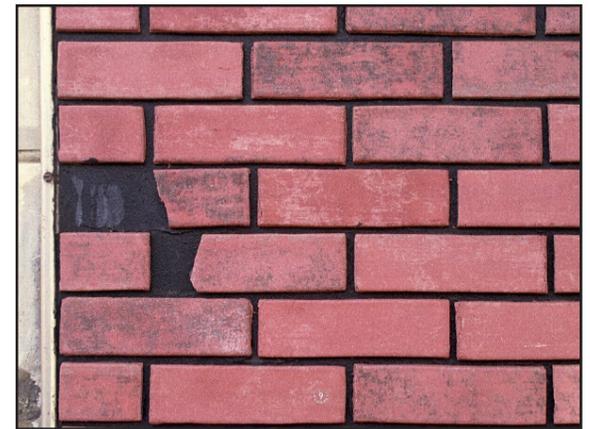
Figure 3.14: This faux brick panel is inappropriate for the District, and as evidenced in the photograph, can easily fall into disrepair.

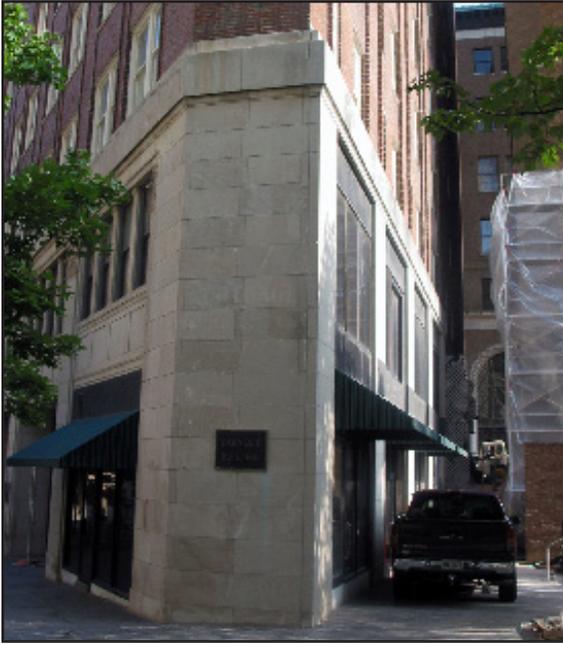
Figure 3.15: This building in downtown Atlanta was appropriately remodeled in the 1980s to continue the limestone base along the rear (right) elevation when an adjacent building was demolished. The new stone is a composite material and matches the historic limestone in texture, color and size.

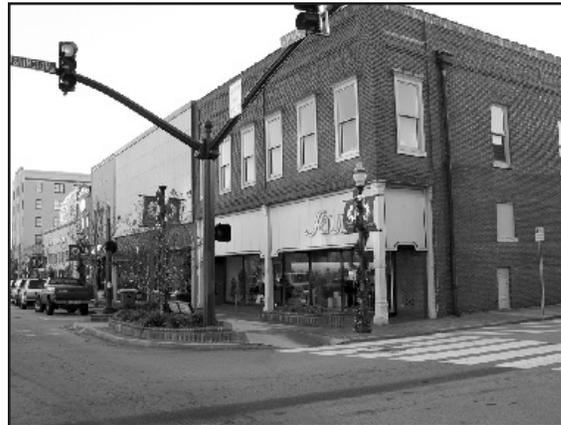
Figure 3.16: The removal of the historic storefront and recessing of the new storefront of this building in Gainesville, GA is inappropriate.

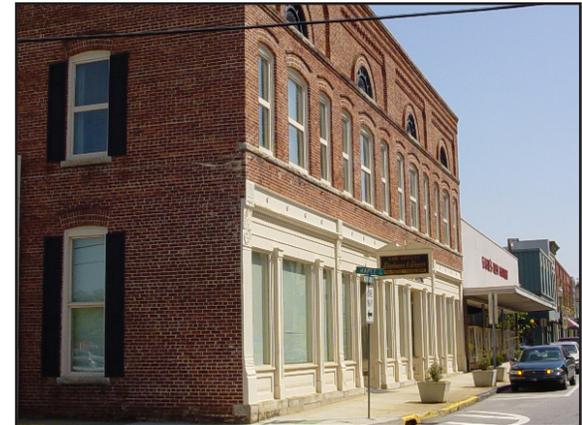
Figure 3.17: This building in Gainesville has appropriately retained the original cast iron columns – a character-defining feature of the building.

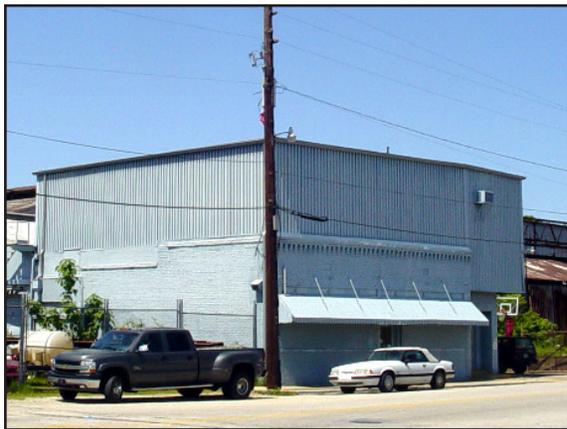
Figure 3.18: The stepped roof of this commercial building in Gainesville, GA has been inappropriately altered with an addition.

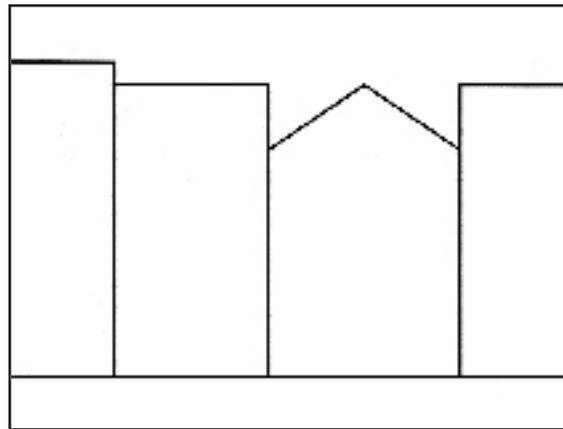
Figure 3.19: If the area of influence of a proposed project site, especially with adjacent buildings, has flat or sloped roofs hidden with parapet wall it is inappropriate to introduce a new roof form, such as a gabled roof.

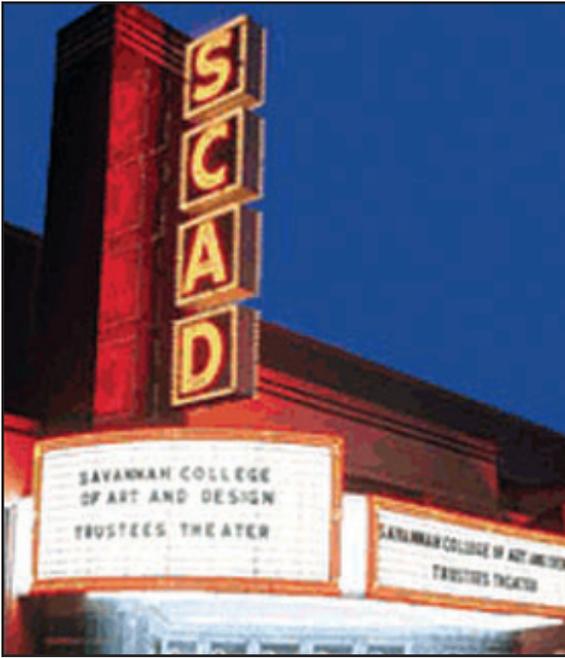
Figure 3.20: Historic lighting features, such as this marquee for this theater in Savannah, GA is an important character-defining characteristic and should be retained during any rehabilitation.

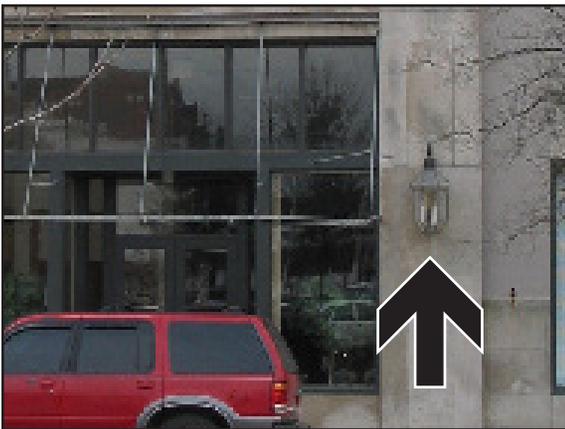
Figure 3.21: The Dixie-Hunt Tower in Gainesville, GA has appropriate modern lighting on its exterior.

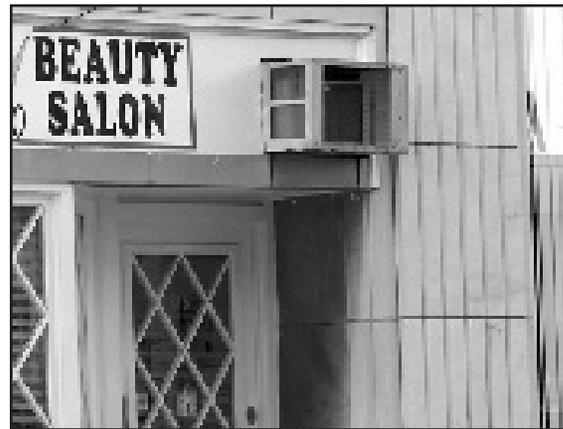
Figure 3.22: This building in Gainesville, GA has inappropriately placed a HVAC unit in the inappropriately modified storefront.

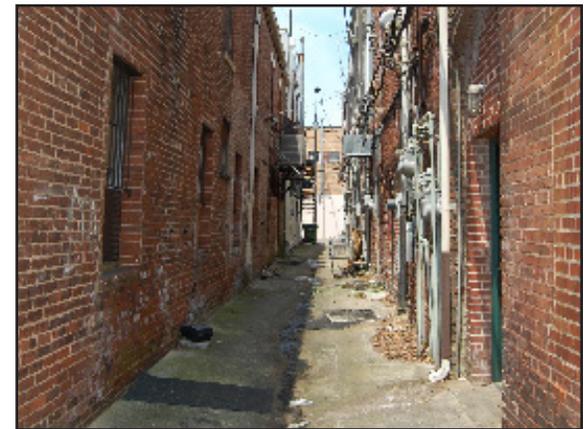
Figure 3.23: This rear alley in Marietta is kept free of obstructions and is appropriately graded to drain.

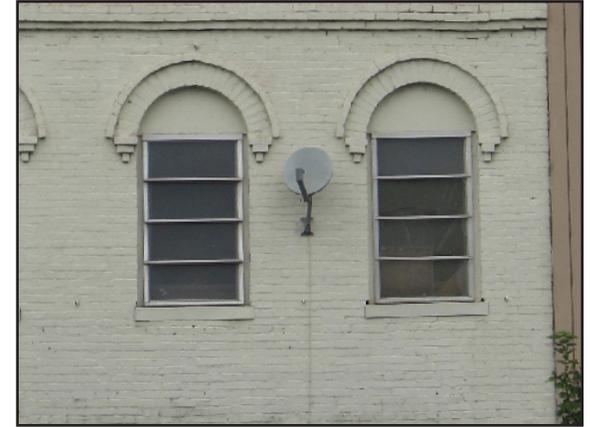
Figure 3.24: This satellite dish has inappropriately been placed on the primary elevation of this commercial building in south Georgia.

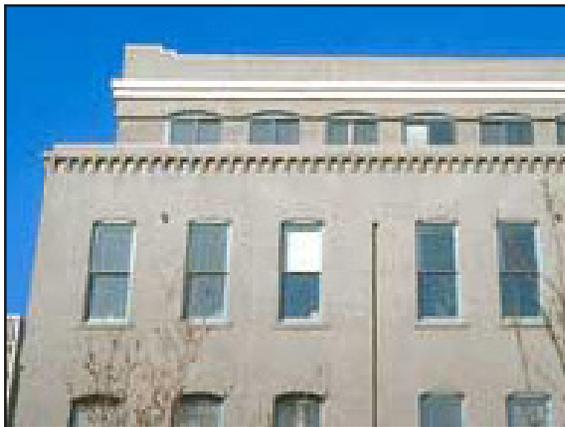
Figure 3.25: This addition to the rooftop is inappropriate because it can be seen from the public-right-of-way and it dramatically changes the form of the historic building.

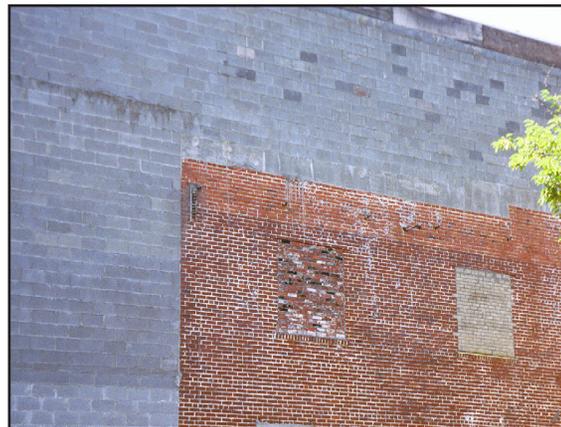
Figure 3.26: This addition has inappropriately encased the original roof form of the building.

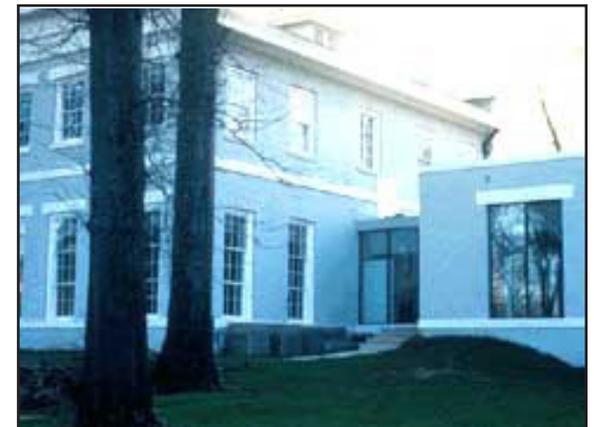
Figure 3.27: A new addition to a historic building can utilize a “connector” which minimally impacts historic materials, etc.

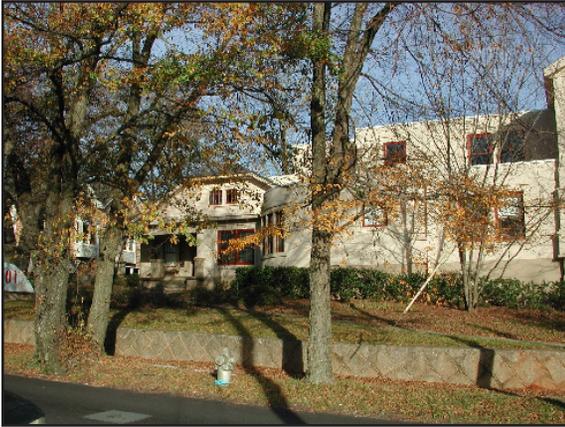
Figure 3.28: This Clipped Roof Bungalow in Stone Mountain, GA was inappropriately expanded by an addition to the front and right elevation that expanded its square footage by over two times the original floor plan.

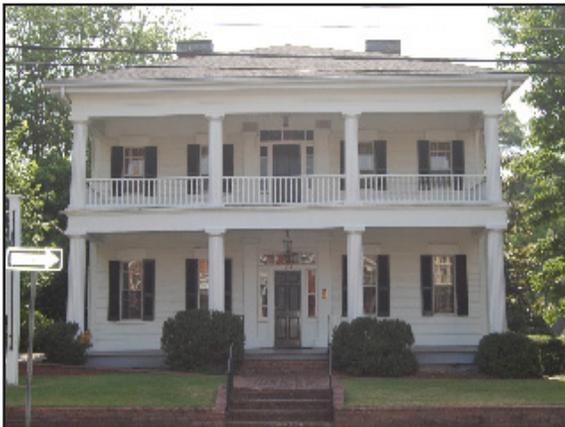
Figure 3.29: This Georgian House on Church Street has been appropriately rehabilitated from a residential use to a commercial, office use. It has retained the residential character-defining features, such as the windows, doors with transom and sidelights and the double verandah.
