Design Guidelines

Kennesaw Avenue Historic District Marietta, Georgia

Revised 2/26/13

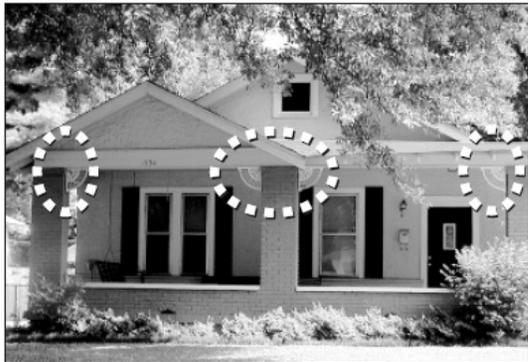
Adding pieces of ornamentation to a building gives a false sense of history.

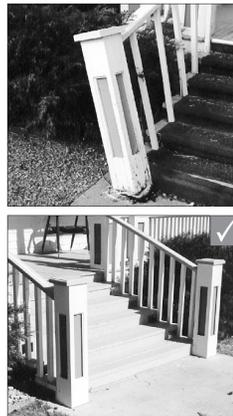
Repair rather than replace historic design elements.

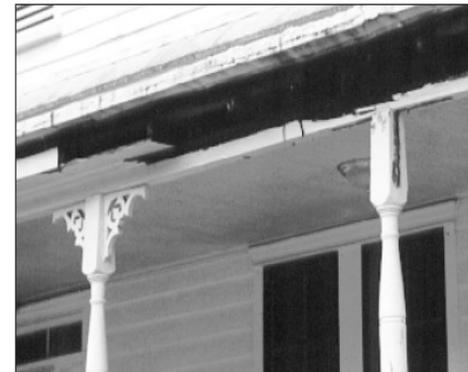
Replace missing decorative elements in kind.

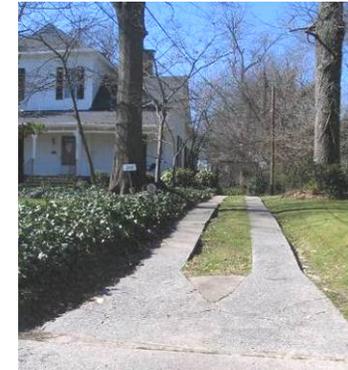
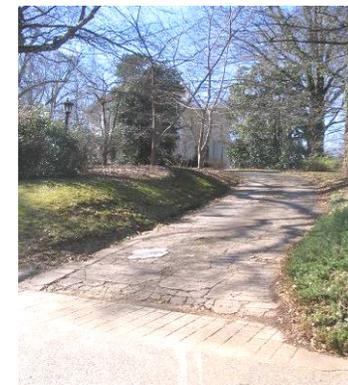
Example of a surviving driveway with two paved wheel tracks separated by a strip of grass and semi-circular driveway in the Kennesaw Avenue Historic District

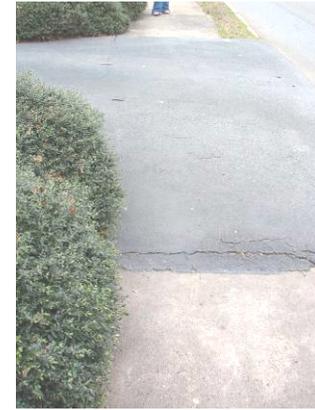
Inappropriate material / application

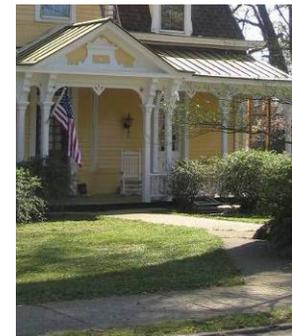
Entrance walk in the Kennesaw Avenue Historic District.

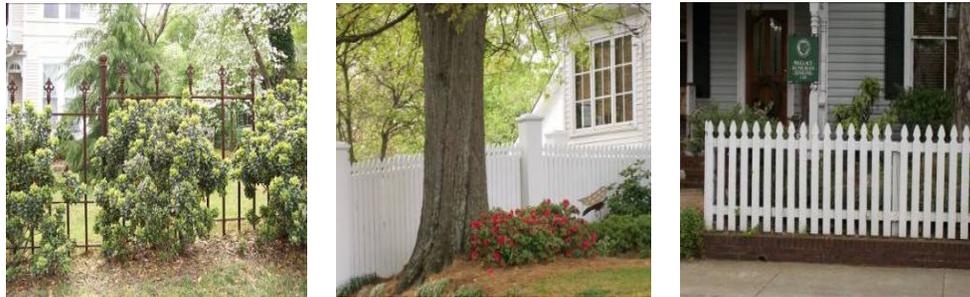
Typical fences in the Kennesaw Avenue Historic District

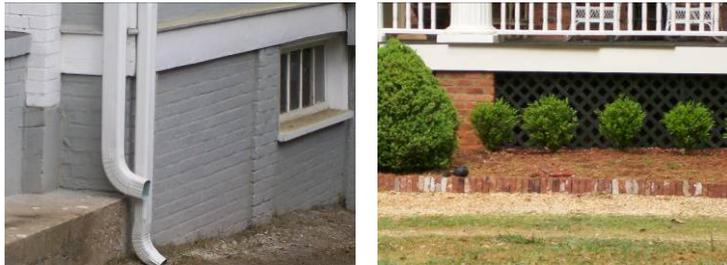
Typical foundations in the Kennesaw Avenue Historic District

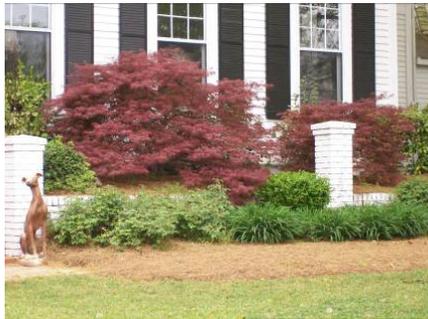
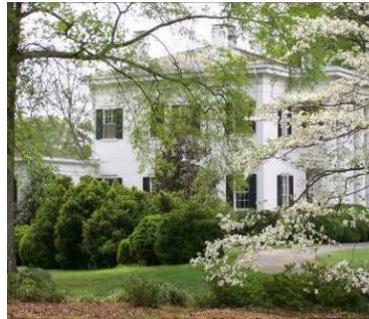
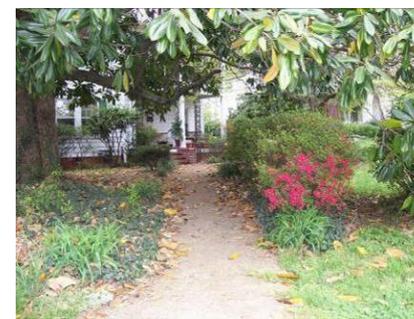
Typical Ornamental Planting in Kennesaw Avenue Historic District

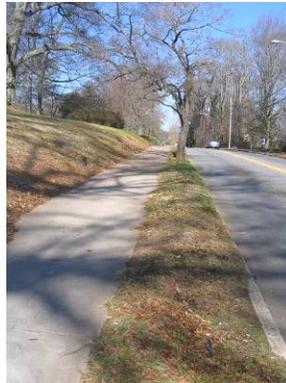
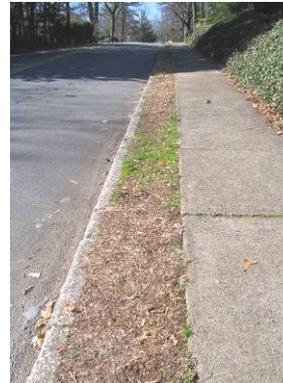
Typical sidewalks in the Kennesaw Avenue Historic District

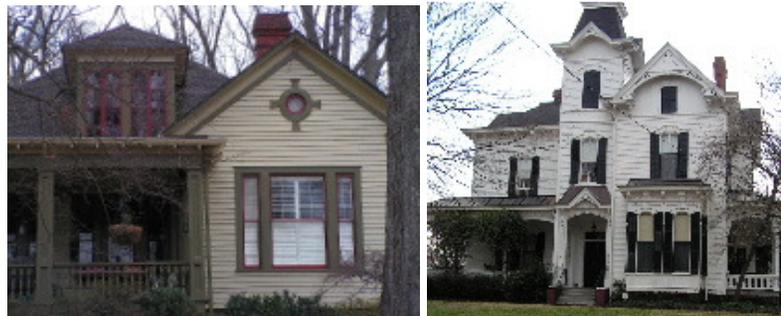
Typical windows in the Kennesaw Avenue Historic District

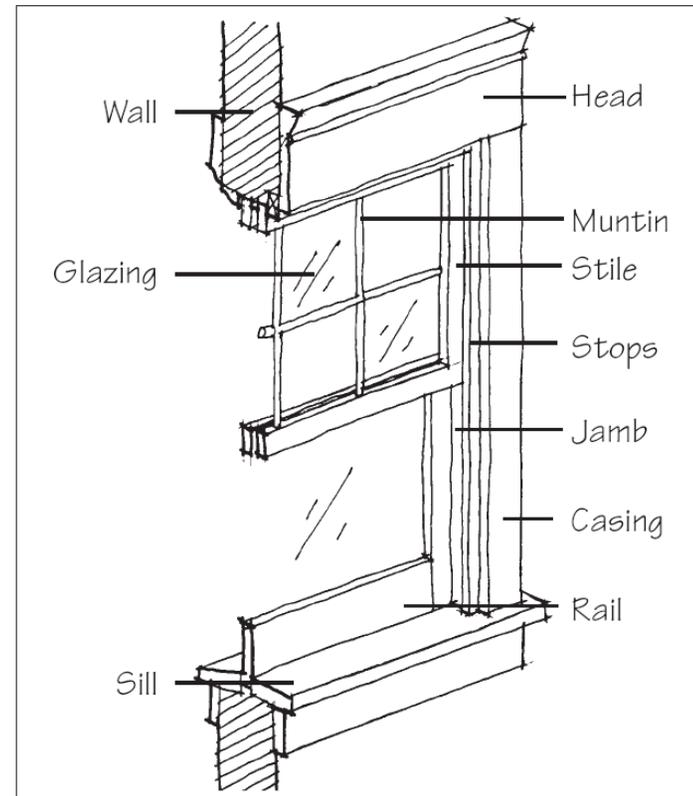
Preserve the functional features of an historic window.

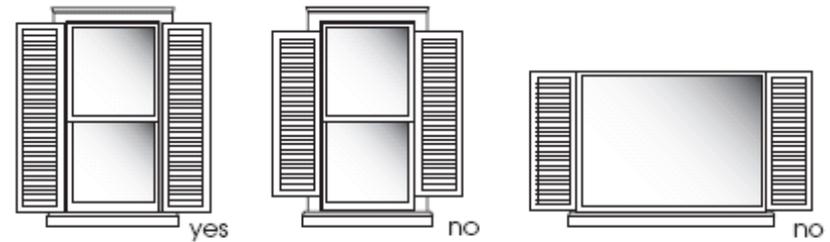
Examples of proper and improper shutter installation

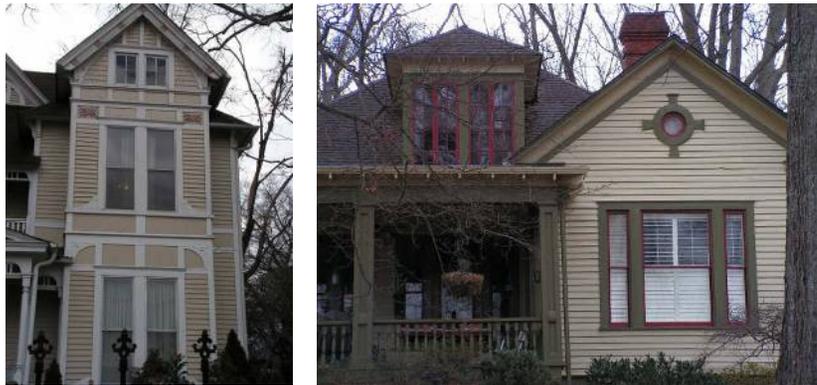
Typical fenestration patterns in the Kennesaw Avenue Historic District.

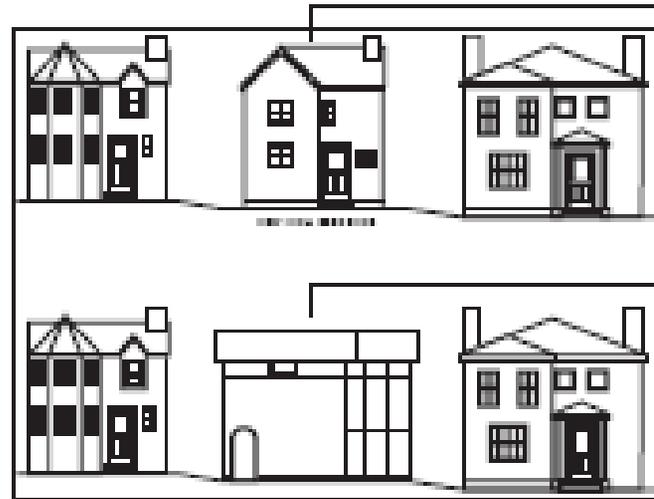
Center structure reflects fenestration of adjacent houses

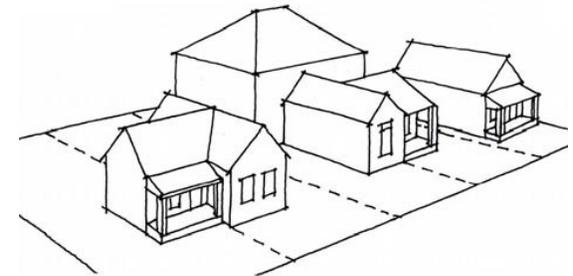
The scale of this rear addition is inappropriate

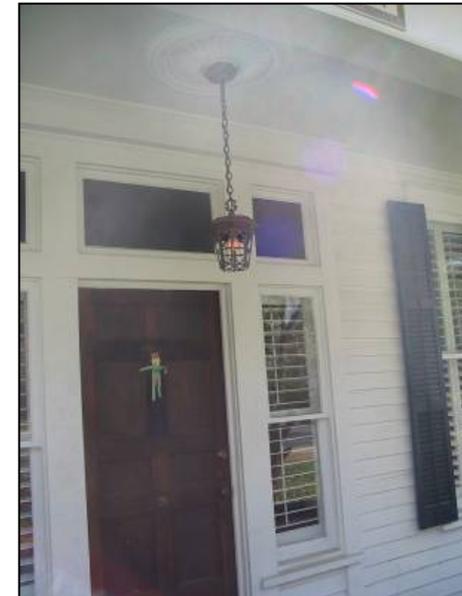
Simple lighting fixtures will not detract from historical details.

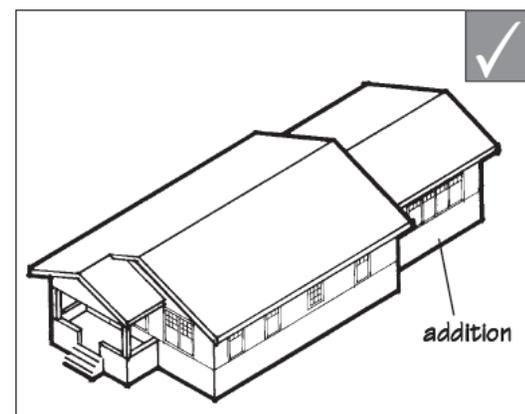
Place an addition at the rear of a building or set it back from the front to minimize the visual impacts.

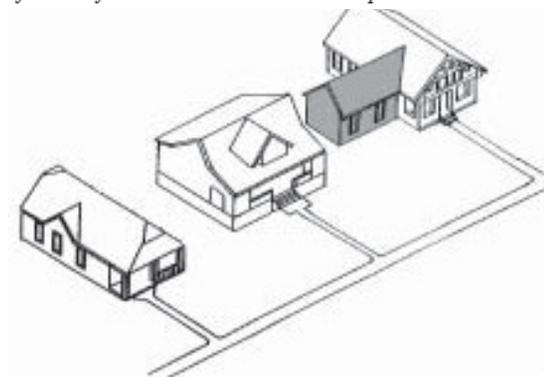
This side yard addition is inappropriate. It significantly reduces the space between the existing historic structures.

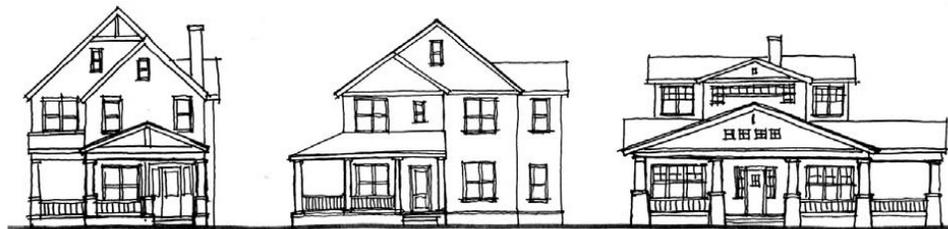
The style and spacing of the windows on the new construction project on the right are not compatible with the existing historic structures.

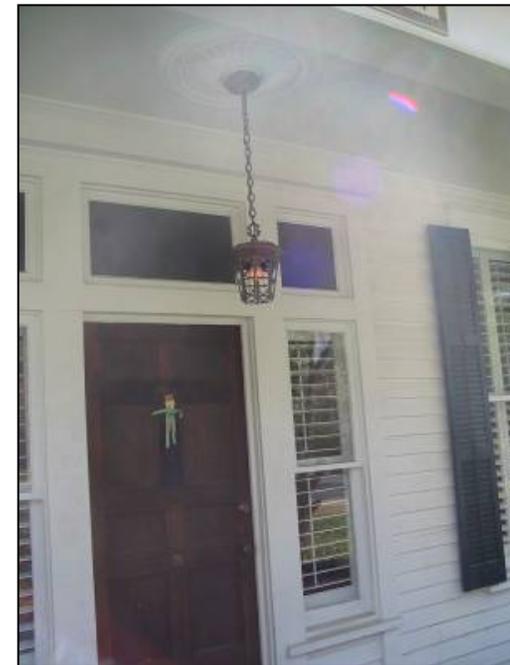
Simple lighting fixtures will not detract from historical details.

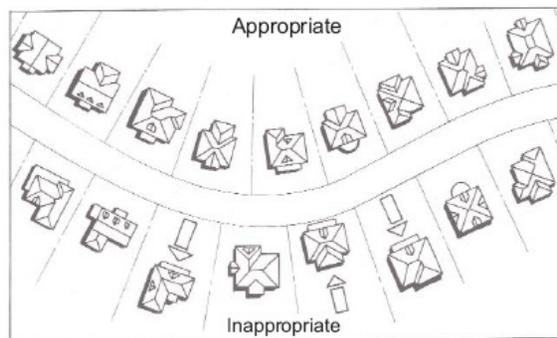
Appropriate and inappropriate front setbacks

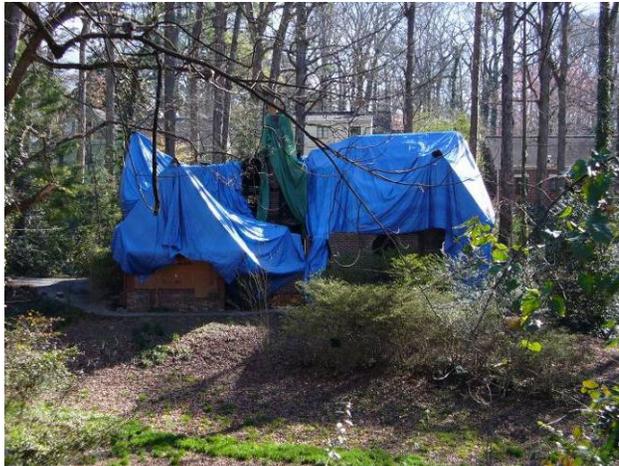
Demolition by neglect

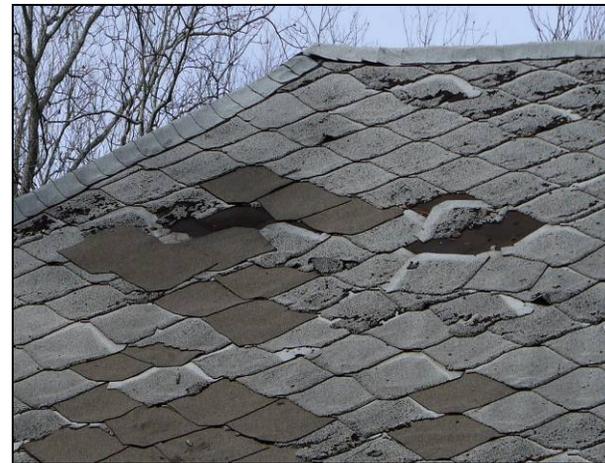
Neglect due to lack of maintenance
